University of Alberta

PERFORMANCE EVALUATION OF 2002 AND 2003 ALBERTA ASPHALT RUBBER PROJECT

Ashim Shivakoti

A thesis submitted to the Faculty of Graduate Studies and Research in partial fulfillment of the requirements for the degree of Master of Science

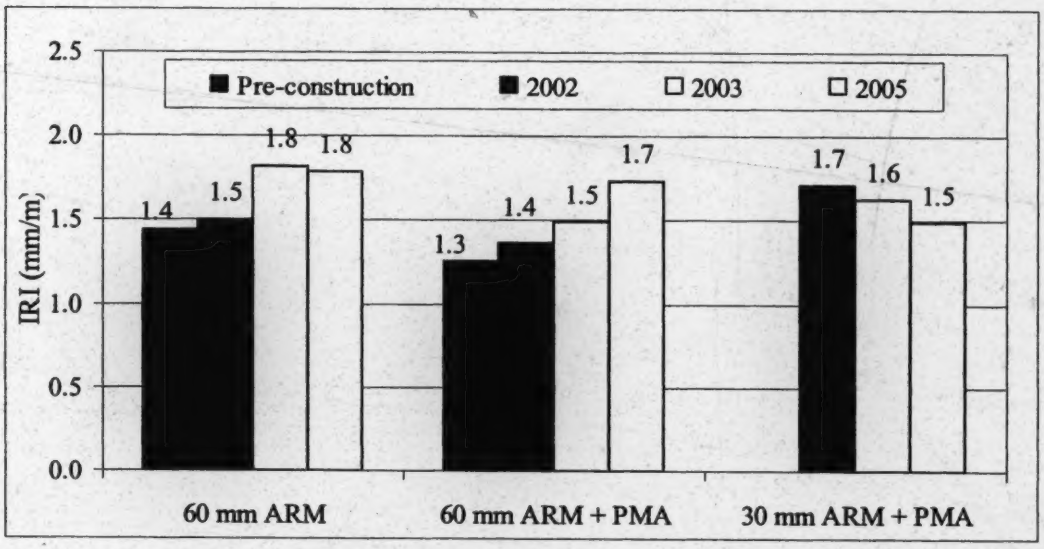
Figure 3.10 Summary of the IRI measurements at the 17 Street project location

The IRI measurements reveal that the post-construction IRI of the ARM sections increased gradually at both 60 mm ARM overlays at a slow rate. However, the 30 mm ARM overlay showed a decreasing IRI trend. Generally, all before and after IRI values were in the range of 1.3 to 1.7, which suggests roughness was not the main reason for overlay and it is in good range three years after overlay. The high rutting measurement before overlay can be attributed to heavy truck traffic and the presence of a signalized intersection at this project location. After overlay with ARM, rutting decreased at all locations of this project. It seems 60 mm ARM overlay and combination of PMA and ARM overlay showed a better rutting performance.

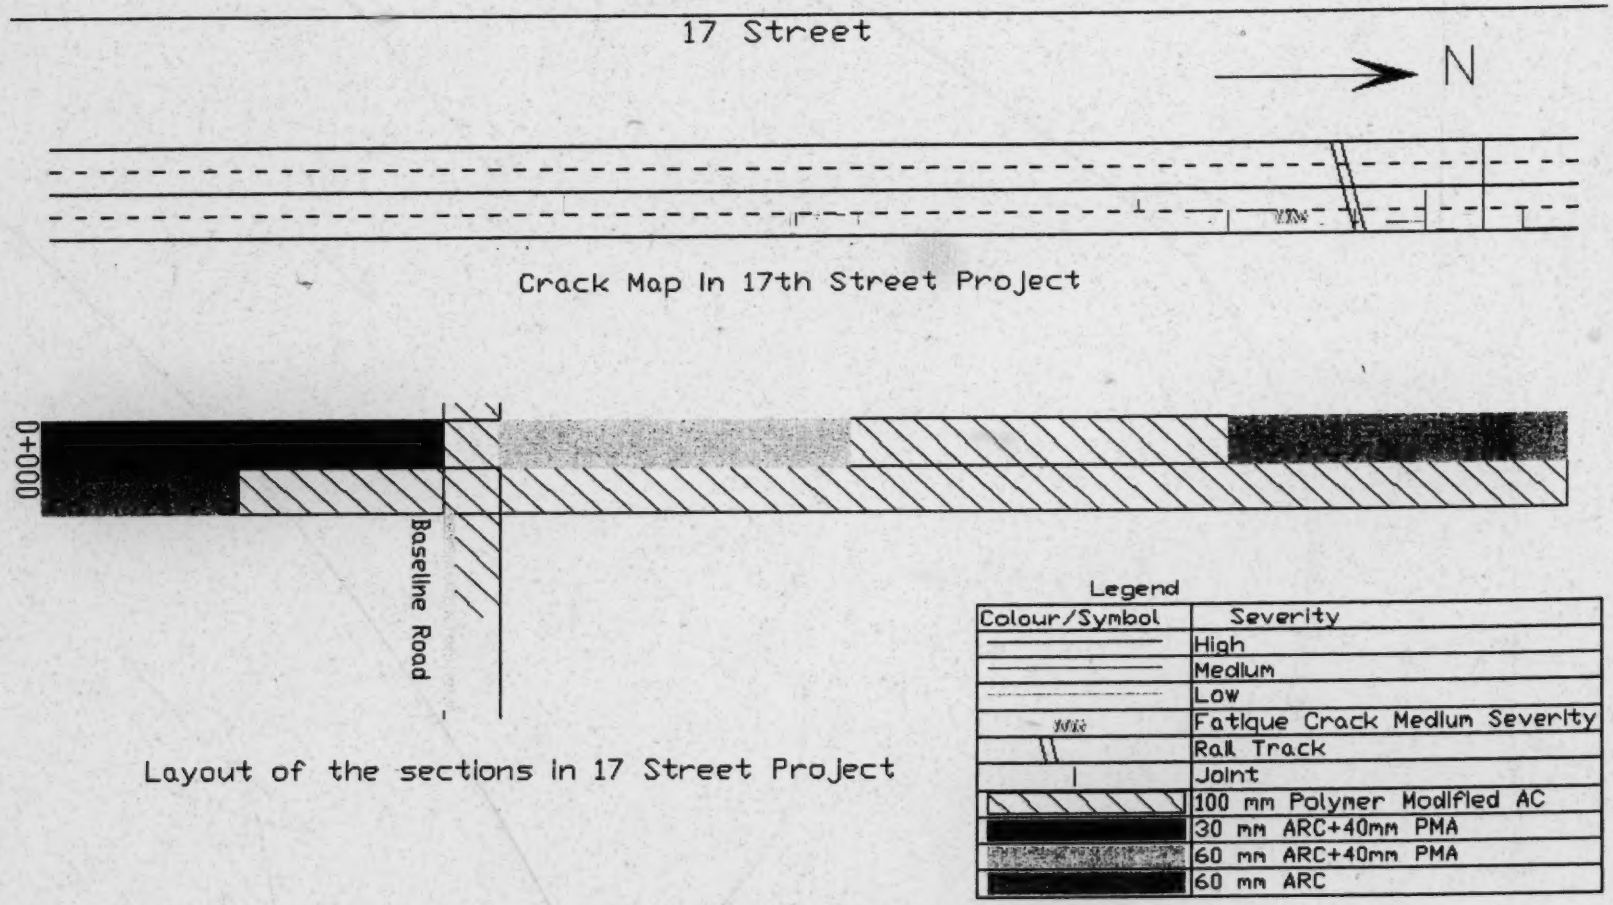
Figure 3.12 Crack measurements at 17 Street project location

Based on the visual surface distress evaluation, it can be concluded that cracking or other surface distresses (ravelling, stripping, patches and pot holes) were not a major problem at the ARM section at the 17 Street project location.

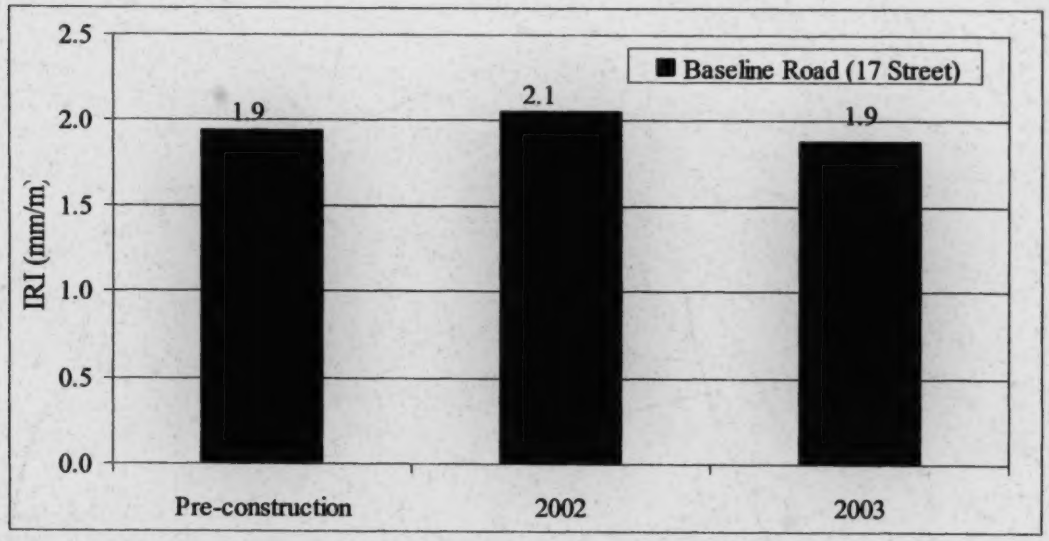
Figure 3.13 Summary of the IRI measurements at the Baseline Road (17 Street)

No substantial increase in IRI was observed one year after construction on the Baseline section. Of all sections paved in 2002, the rutting measurement at this project location is the highest. As previously mentioned, this can be attributed to the heavy truck traffic and the presence of a signalized intersection.

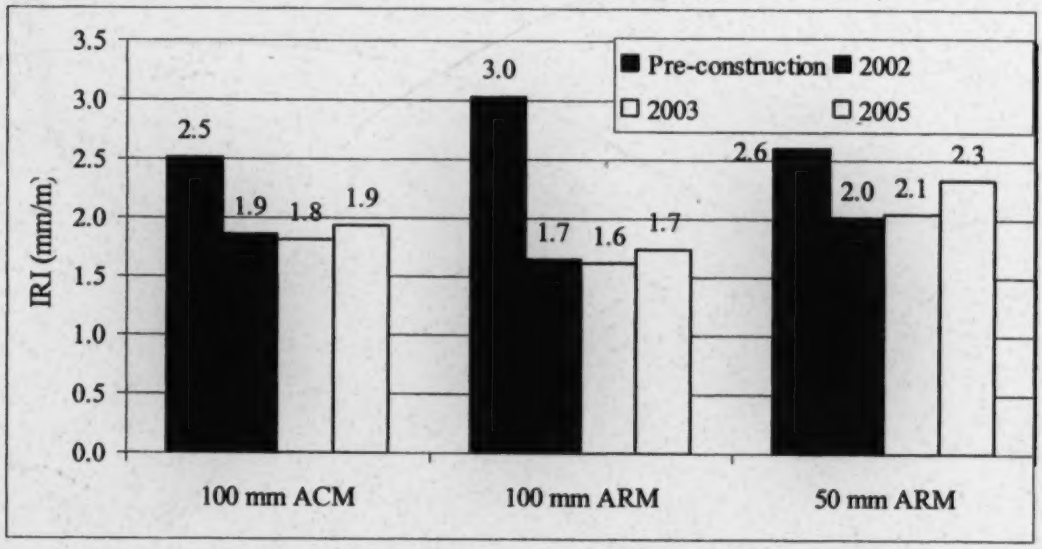
Figure 3.15 Summary of IRI measurements at the 137 Avenue project location

As expected, increase in IRI for 100 mm ARM and ACM sections are relatively less compared to the 50 mm ARM section. However, there is no substantial difference in the performance of the 100 mm ACM and ARM sections from an IRI perspective. The rate of IRI increase is also very low at this project location. Regarding rutting, the pre-construction rutting of pavement section overlaid with ACM was higher compared to pavement sections overlaid with ARM. The post-construction rutting of ACM overlay increased by time. However; the rutting of ARM sections are showing a decreasing trend. This rutting decreasing trend can be attributed to changes in measurements year by year and the fact that the accuracy of the rut measuring equipment is $\pm$1 mm.

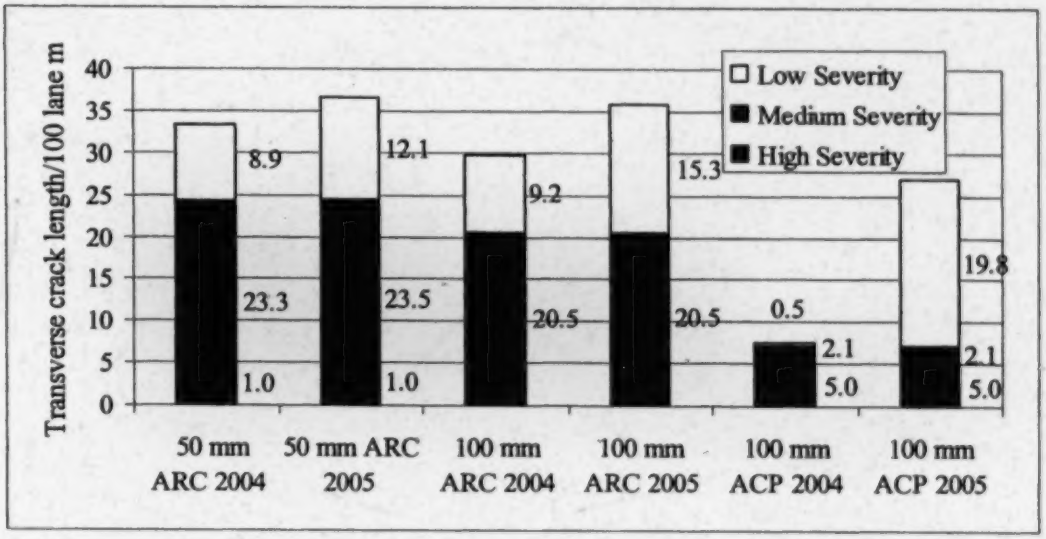
Figure 3.17 Transverse crack measurements at 137 Avenue project locations

The ARM sections at this project location were most severely affected by cracks compared to other sections paved in 2002. Most of the cracks observed in 2004 in the ARM sections were spaced uniformly, suggesting it might be because of the PCC base underneath. No significant cracks were measured in the ACM sections in 2004. In the 2005 measurements, it was observed that all the cracks measured in 2004, and the cracks measured in 2005 in the ACM section, were sealed. It is evident from the measurements in 2005 that more cracks appeared in the ACM sections compared to the ARM sections. Almost all of the new cracks observed in 2005, in the rubber section, were of low severity.

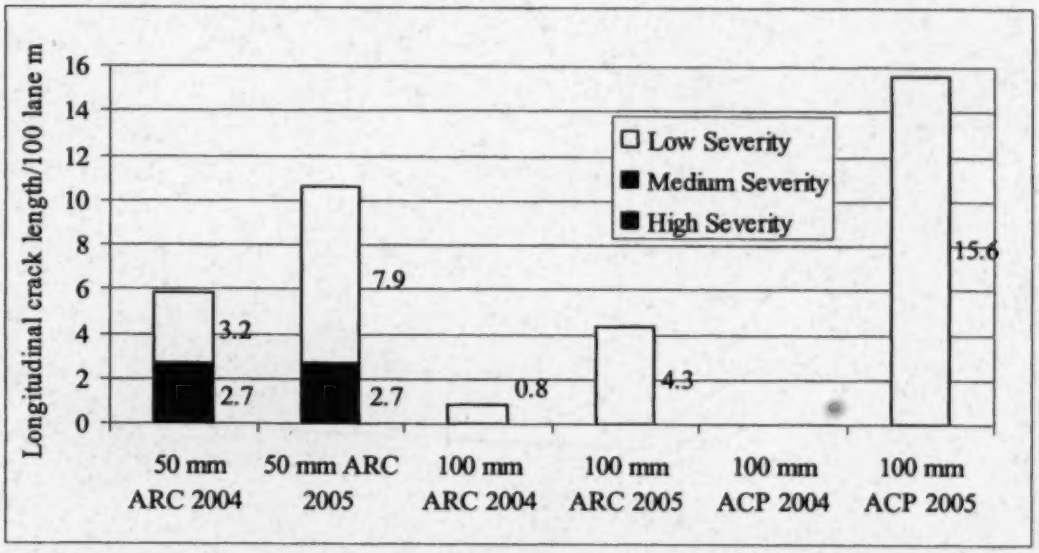
Figure 3.18 Longitudinal crack measurements at 137 Avenue project locations

Table 3.21 presents the summary of the crack measurements conducted at the 137 Avenue project location during the summer of 2004 and 2005. For convenience, the measurements in Table 3.21 have been presented in Figures 3.17 and 3.18 as well. Figure 3.19 presents the crack measurements at the 137 Avenue project location.

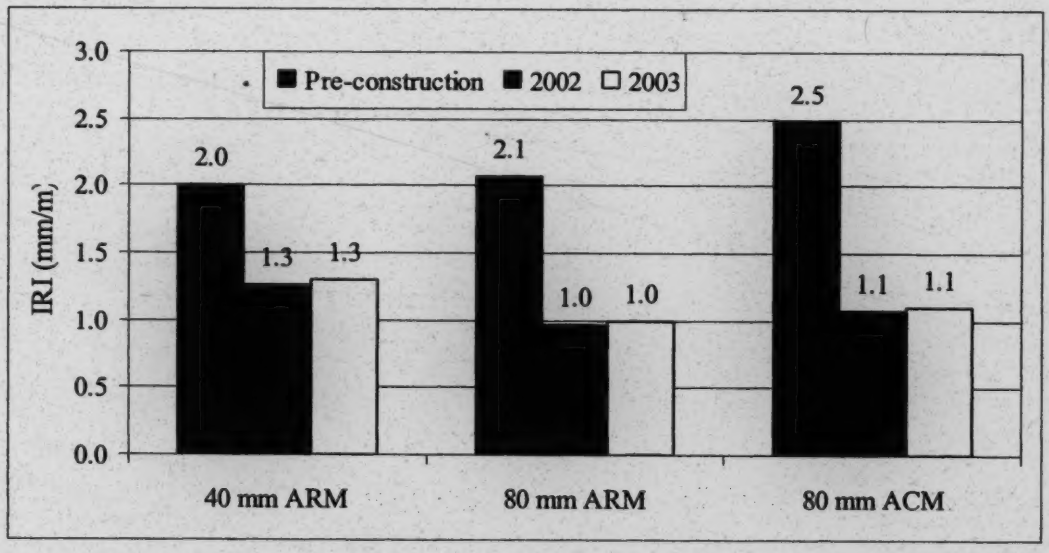
Figure 3.20 Summary of IRI measurement at Highway 630 project location

As expected, the 80 mm ARM and ACM section has performed better than the 40 mm ARM section from both rutting and IRI perspective. However, the difference in the IRI values between the 40 and 80 mm pavement sections is not significant. The rate of IRI increase at this project location is extremely low. The rutting measurements at this project location indicate that the ACM pavement section performed better than the ARM section. However, the difference in the rutting measurement between the 80 mm ARM and ACM sections is not substantial.

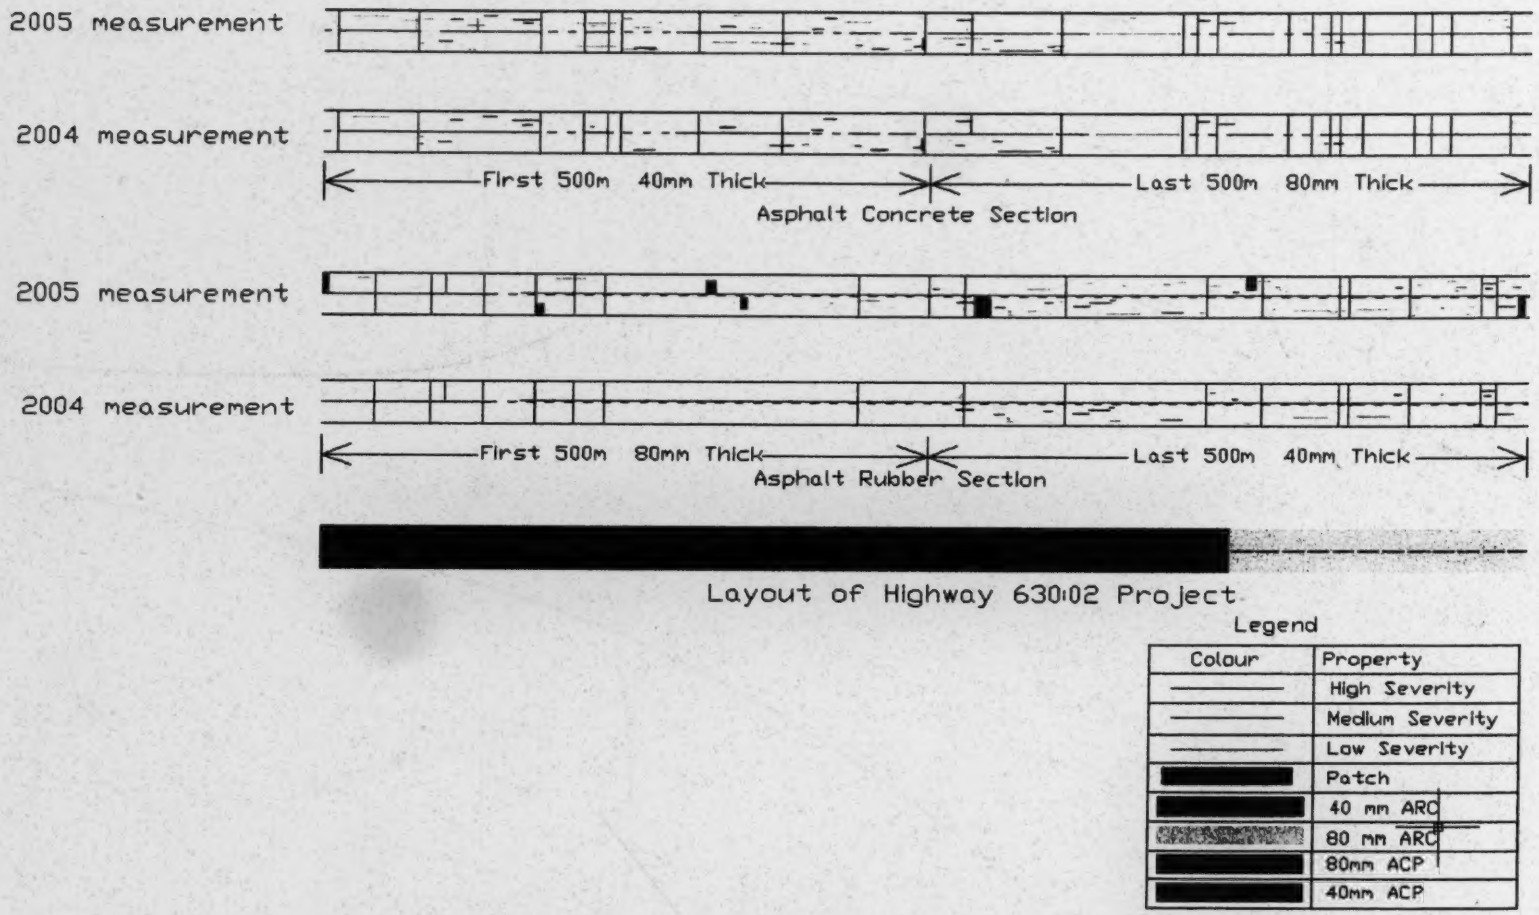
Figure 3.22 Crack measurement map at Highway 630:02 project location

It is evident from the measurements that most of the cracks in 2004 were of high severity, except for the 80 mm ARM section where more medium severity crack was observed. It is to be noted that the majority of the longitudinal cracks observed at this project location were construction joints between two lanes. Based on the crack measurements from 2004 no sections can be considered superior to the other one. No substantial increases in cracks were observed in the pavement sections at this project location in 2005. However, few patches were observed in the ARM section in 2005.

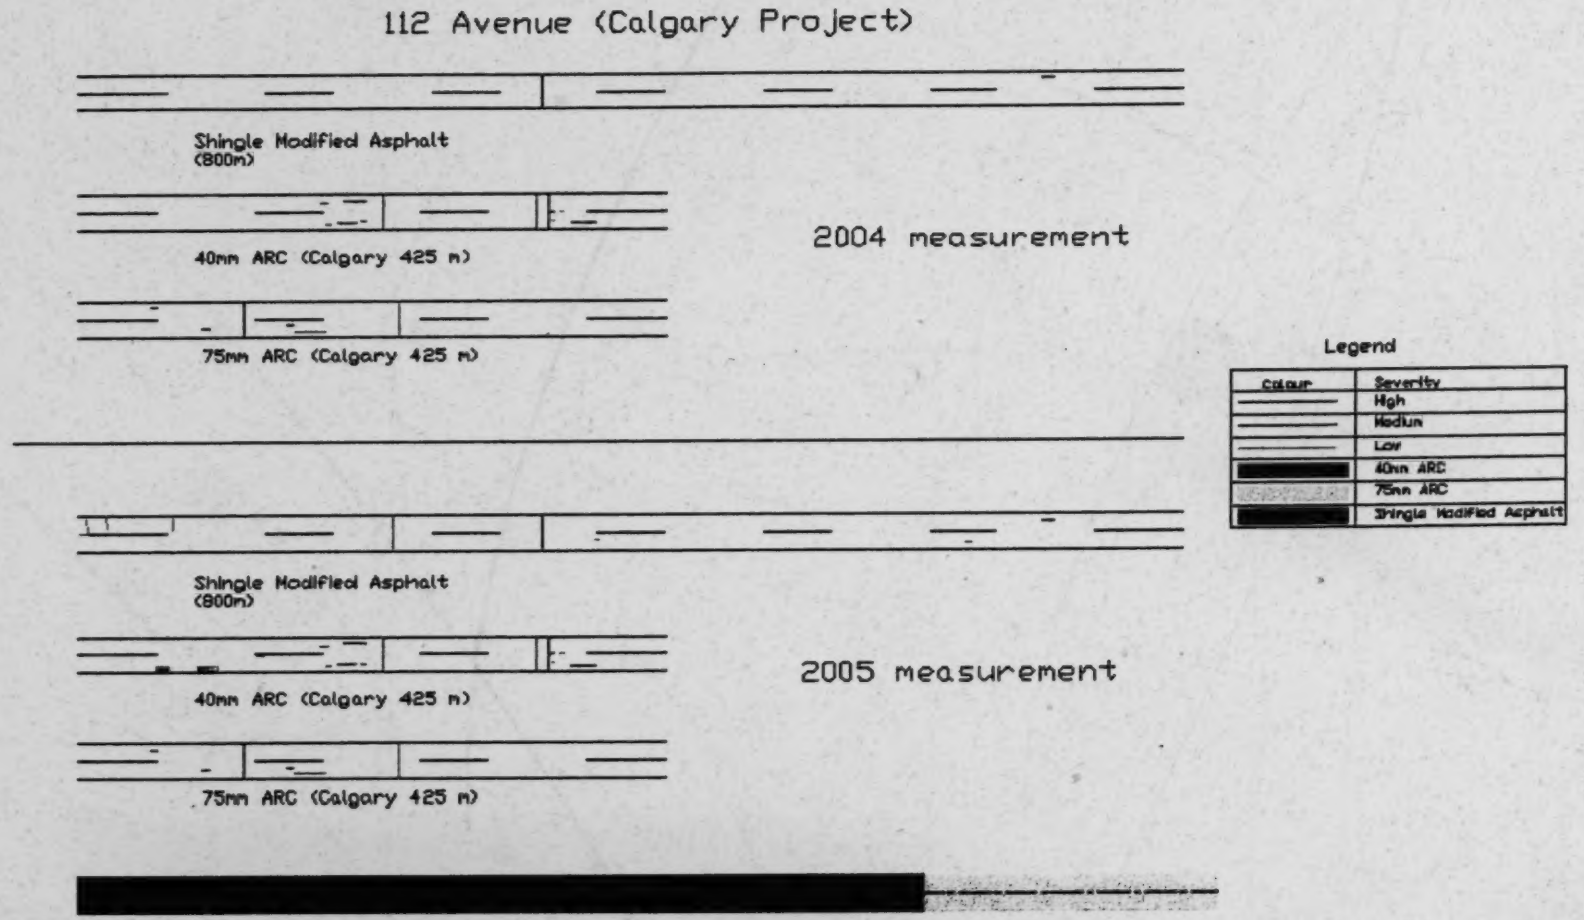
Figure 3.25 Crack measurements map at the 112 Avenue project location

Among all the projects visually observed during the summer of 2004, the pavements sections at this project location showed the least amount of transverse and longitudinal cracks. As expected, both 75 mm ARM and SAM sections performed better compared to the 40 mm ARM section, from a cracking perspective. Almost no increase in the cracking was observed in the 2005 measurement.

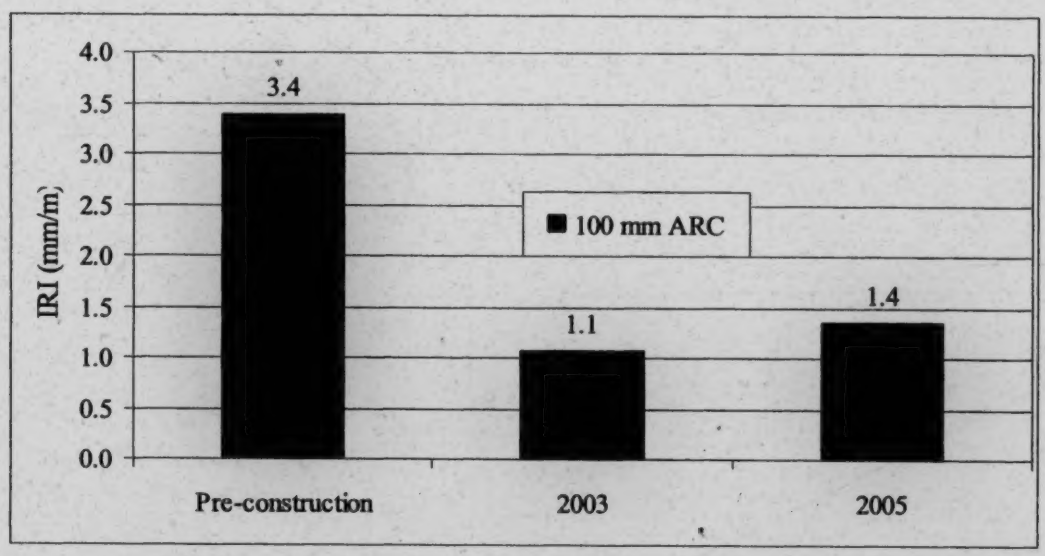
Figure 3.26 Summary of the IRI measurement at 50 Street project location

The IRI increase at this project location is not substantial. Rutting measurement reveals a decreasing trend at this project location. This can be attributed to change in measurements year by year and the fact that the accuracy of rut measuring equipment is $\pm$1 mm.

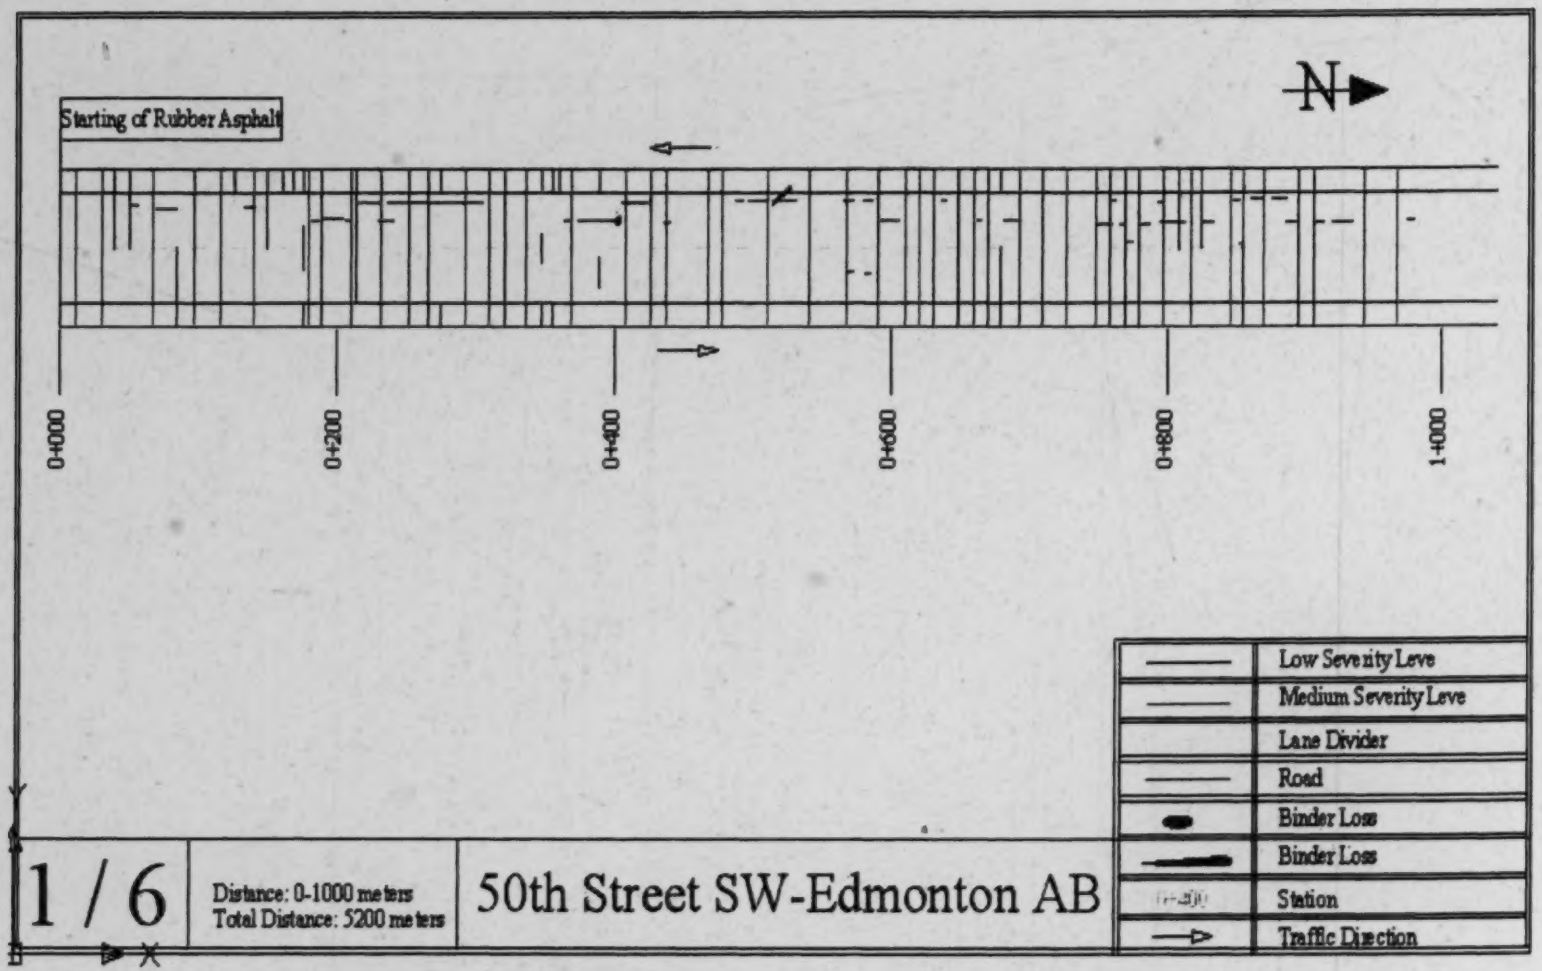
Figure 3.28A Crack measurements map at the 50 Street project locations (0-1000 m)

As shown in Figure 3.28 most of the cracks were concentrated in the section between 41 Avenue SW and Ellerslie Road. It is evident from Table 3.24 that a majority of the cracks are of low severity.

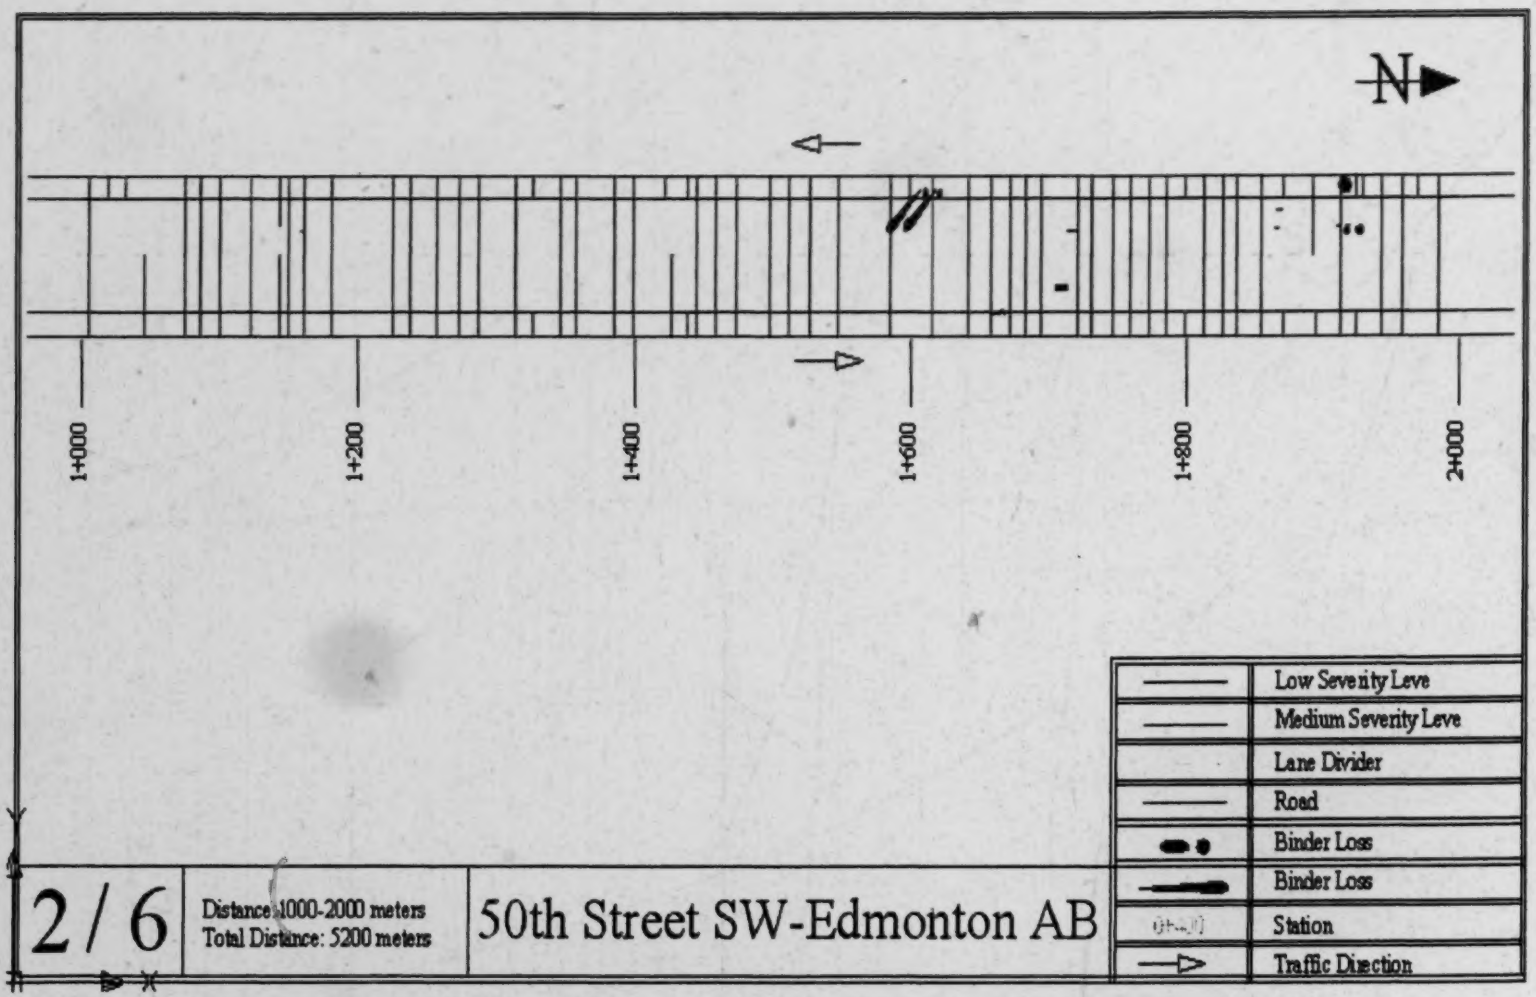
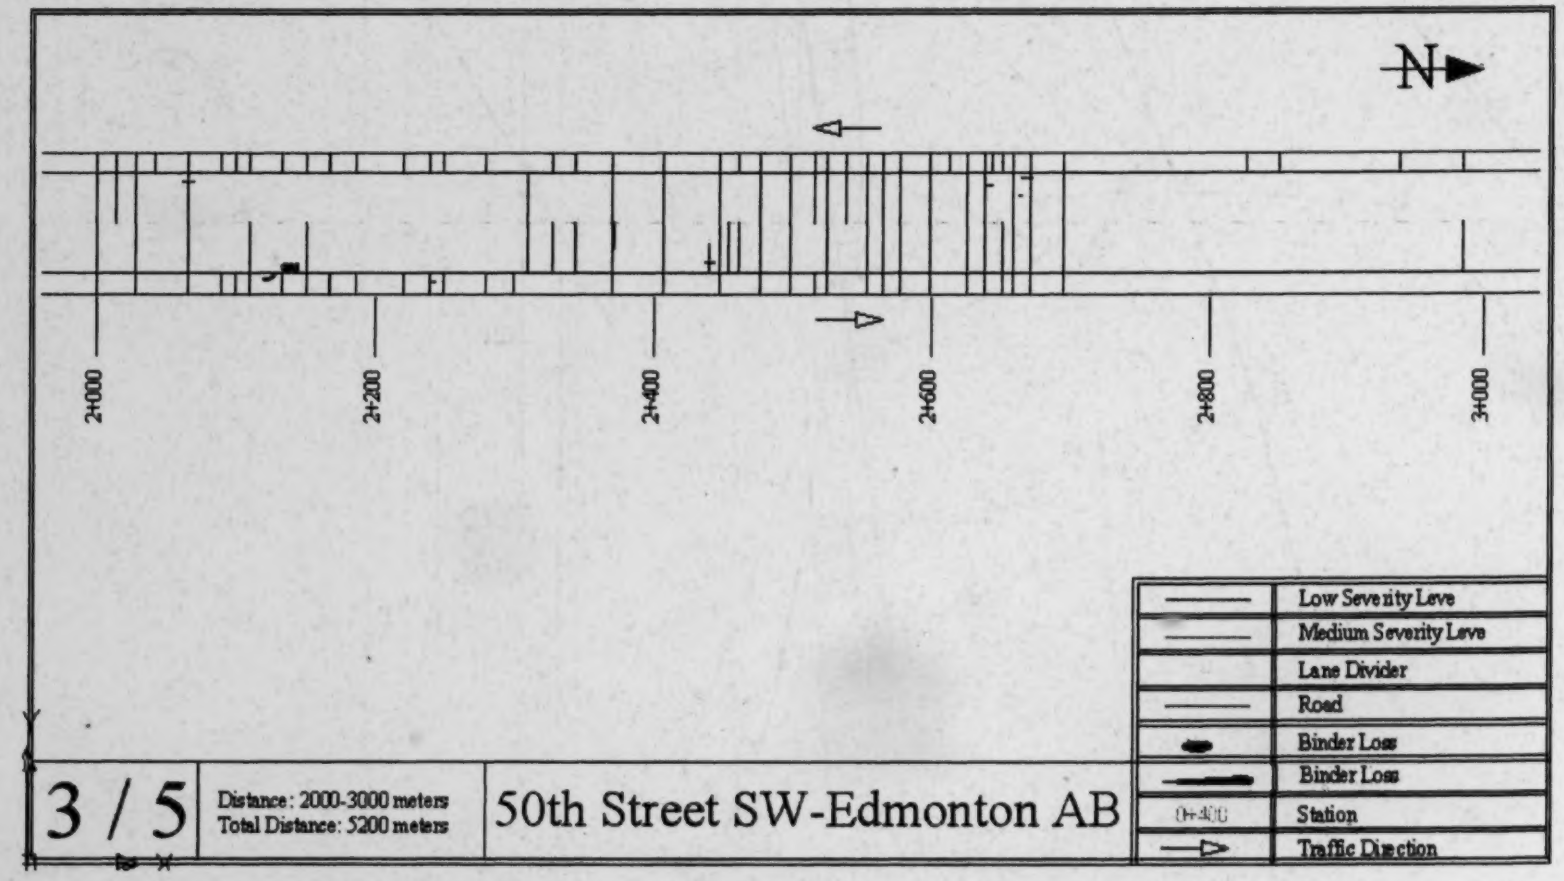
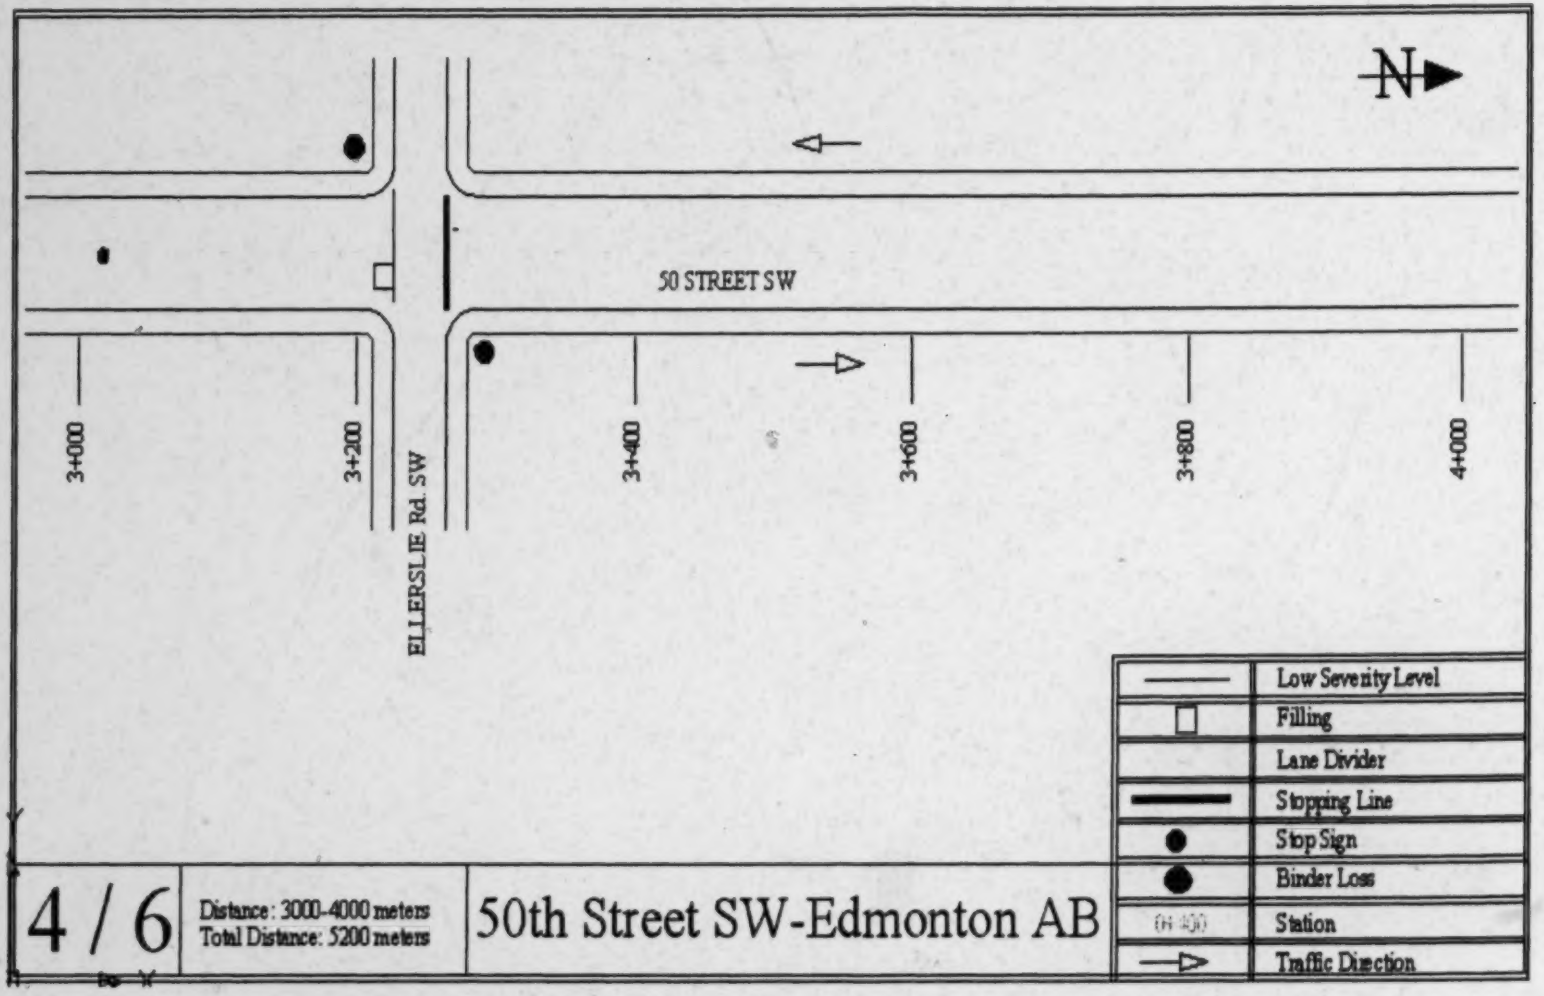
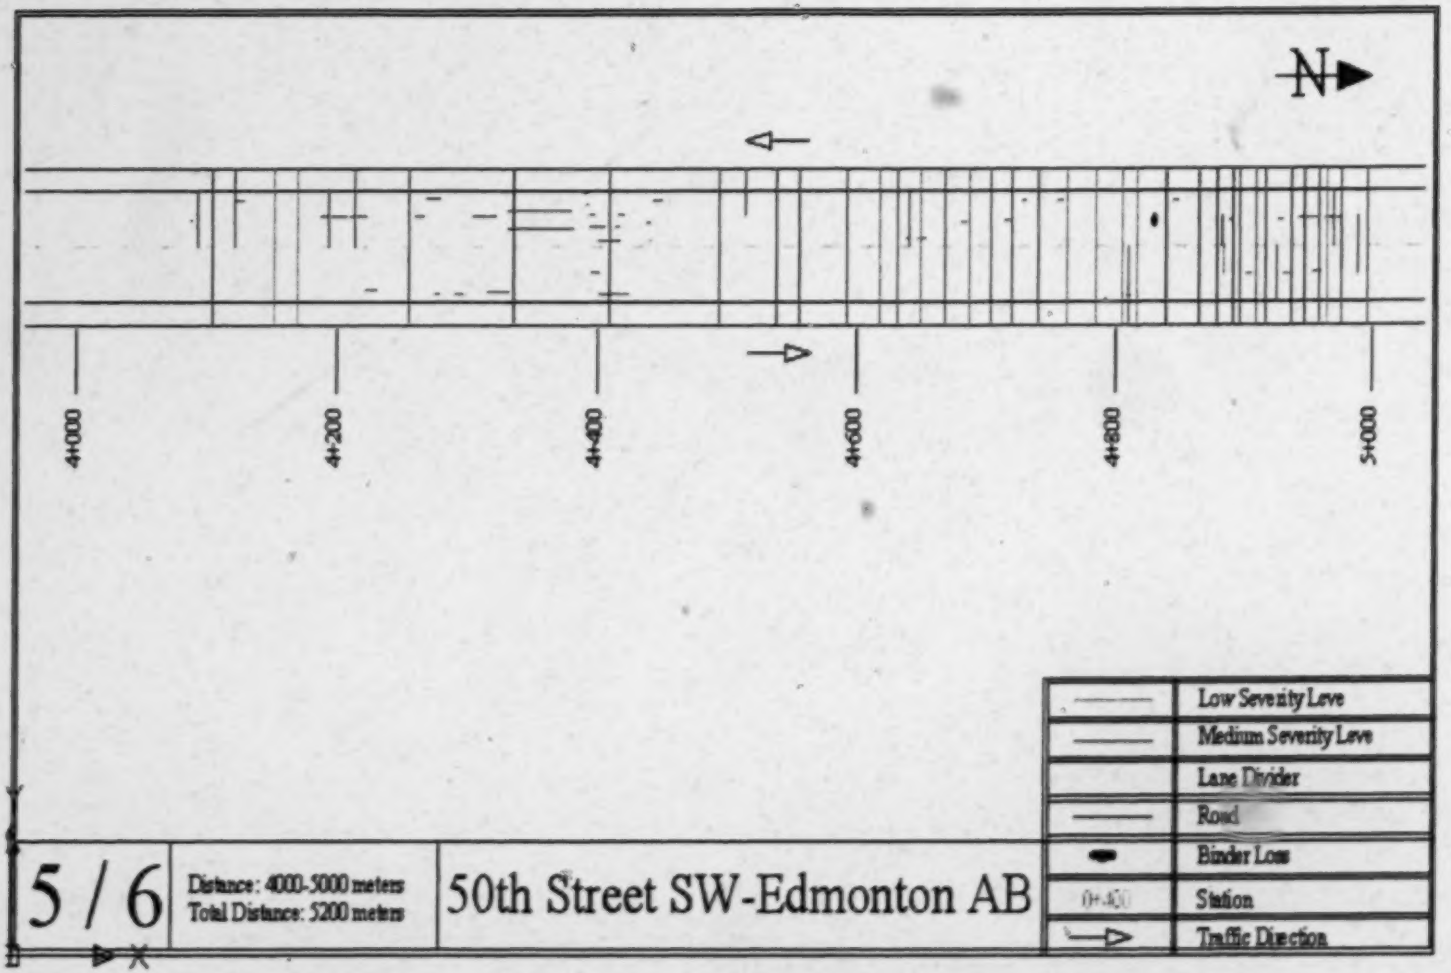
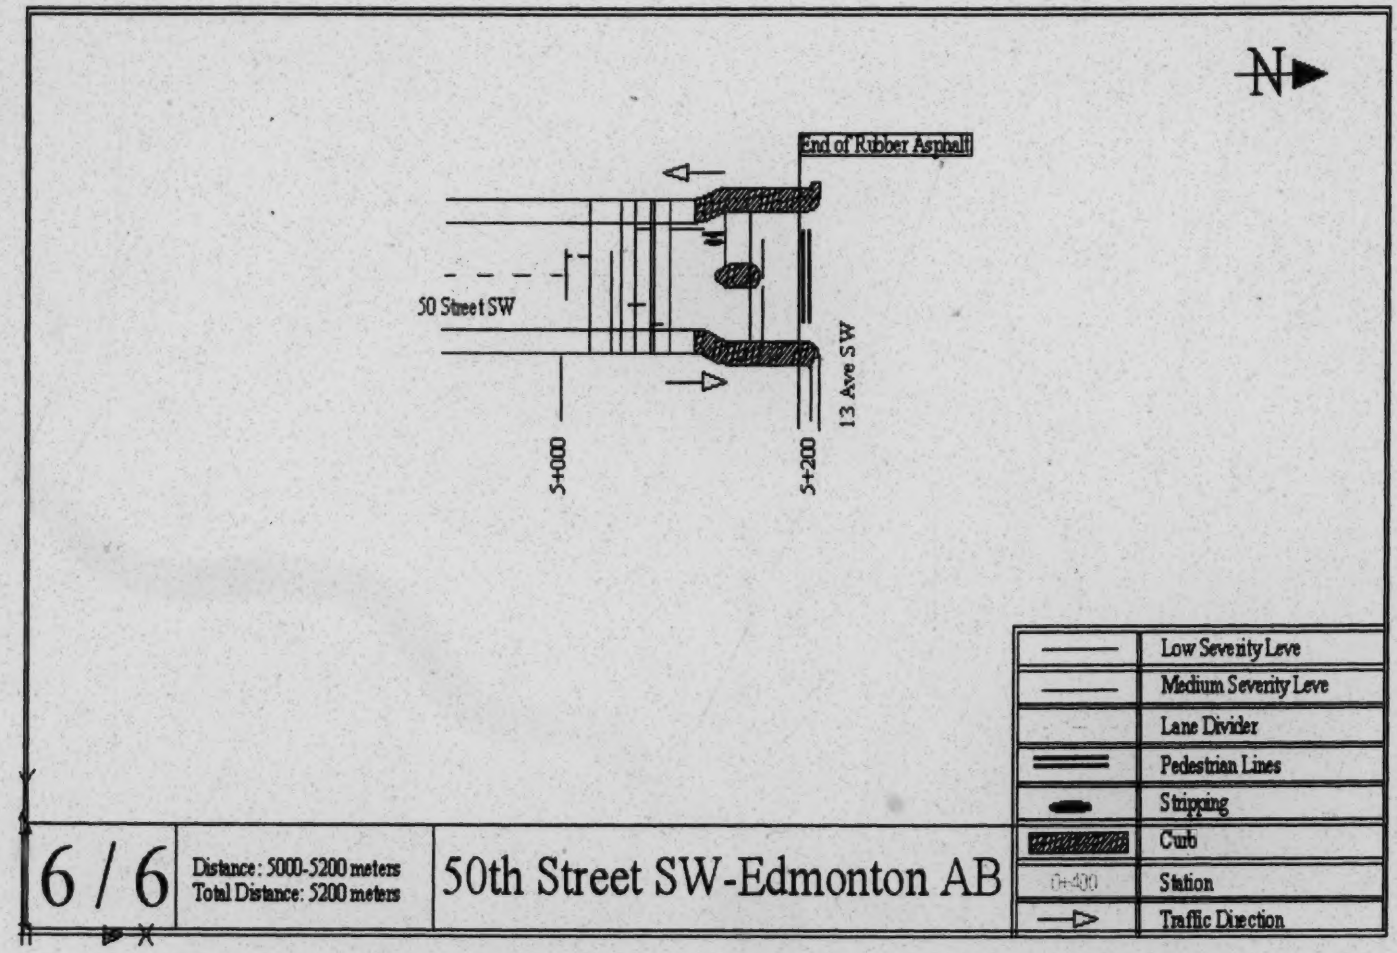
Distress Type	Severity	Normalized distress/100 lane m
Transverse crack (m)	High	0.00
	Medium	4.34
	Low	13.24
	Total	17.58
Longitudinal crack (m)	High	0.00
	Medium	0.00
	Low	8.58
	Total	8.58
Ravelling (m^2)		0.48

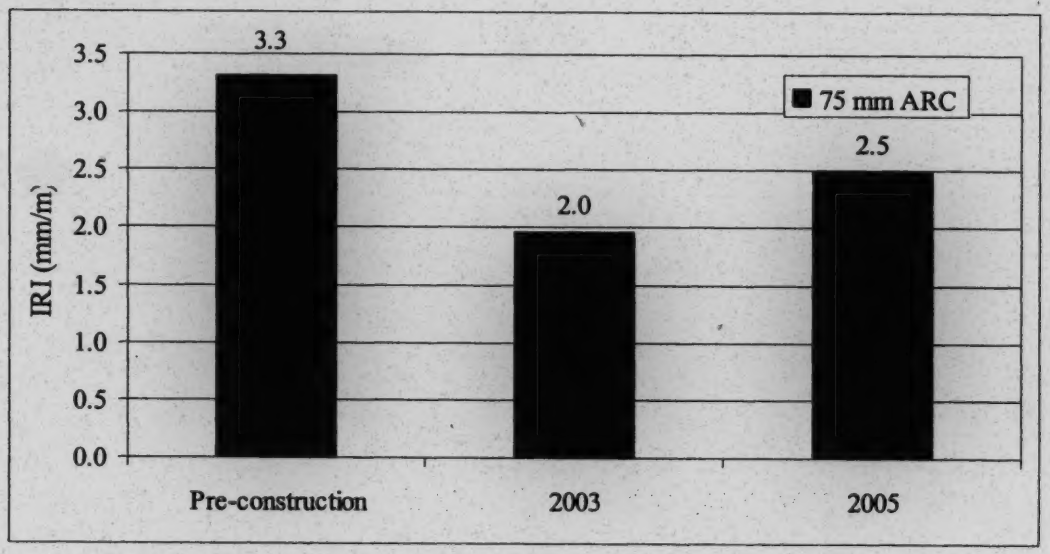
Figure 3.29 Summary of the IRI measurements at the Stony Plain Road

Both the IRI and rut measurements at this project location appear to be slightly higher compared to the 50 Street project location.

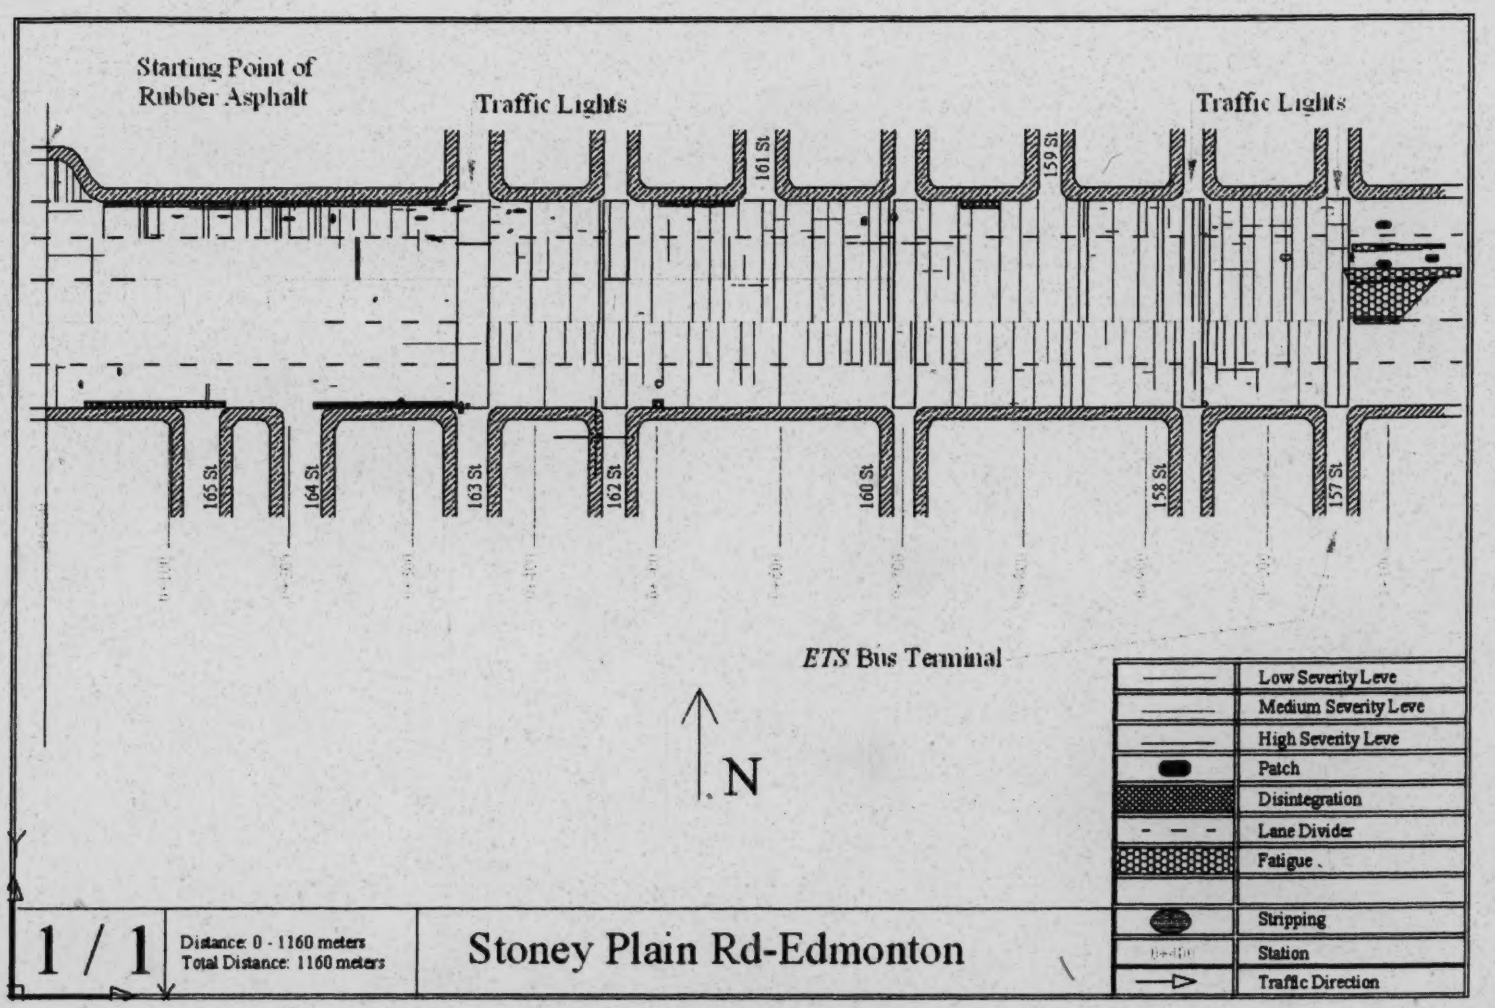
Figure 3.31 Crack measurements map at the Stony Plain Road

The ARM pavement section, at this project location, showed the highest occurrence of surface distresses compared to other pavement sections paved in 2003. Both transverse and longitudinal distresses were distributed uniformly along the length of the ARM section. Significant amounts of moisture damage were observed at this project location. A majority of the moisture damages were concentrated on the edge of the pavement and close to the intersections. As shown in Figure 3.31, a portion of the pavement close to the Edmonton Transit Services (ETS) bus terminal had failed shortly after paving because of fatigue cracking and showed substantial surface depression. High load and low speed clearly showed the limitation of ARM at highly stressed location.

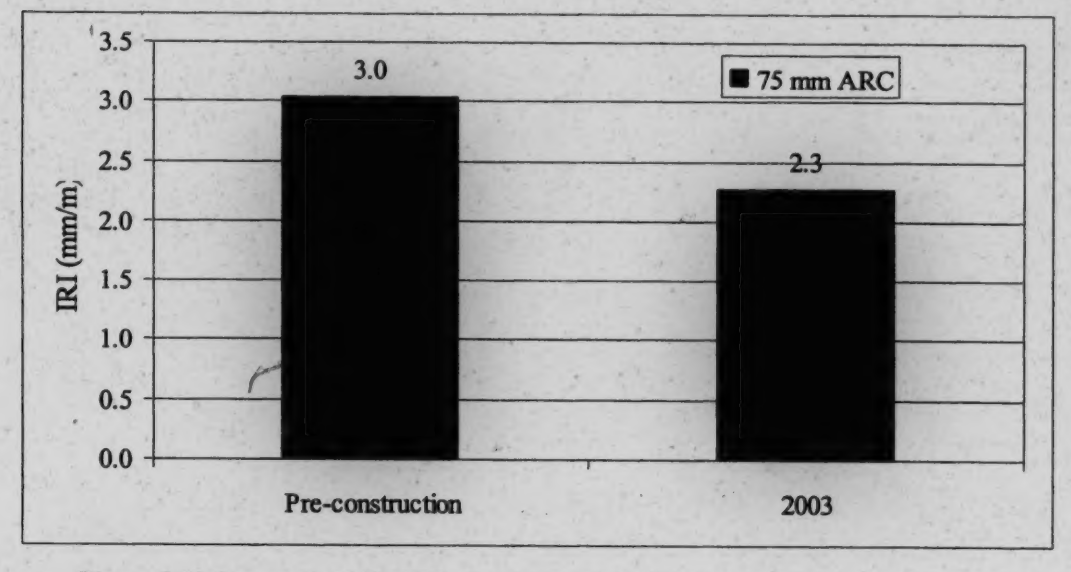
Figure 3.32 Summary of the IRI measurement at the 111 Avenue project location

The IRI measurement, at this project location, immediately after the construction was the highest compared to any other 2002 and 2003 ARM pavement sections.
